Lake Taupo Erosion Study – Stage 4

Prepared for

Taupo District Council
& Environment Waikato (Clients)

March 2008

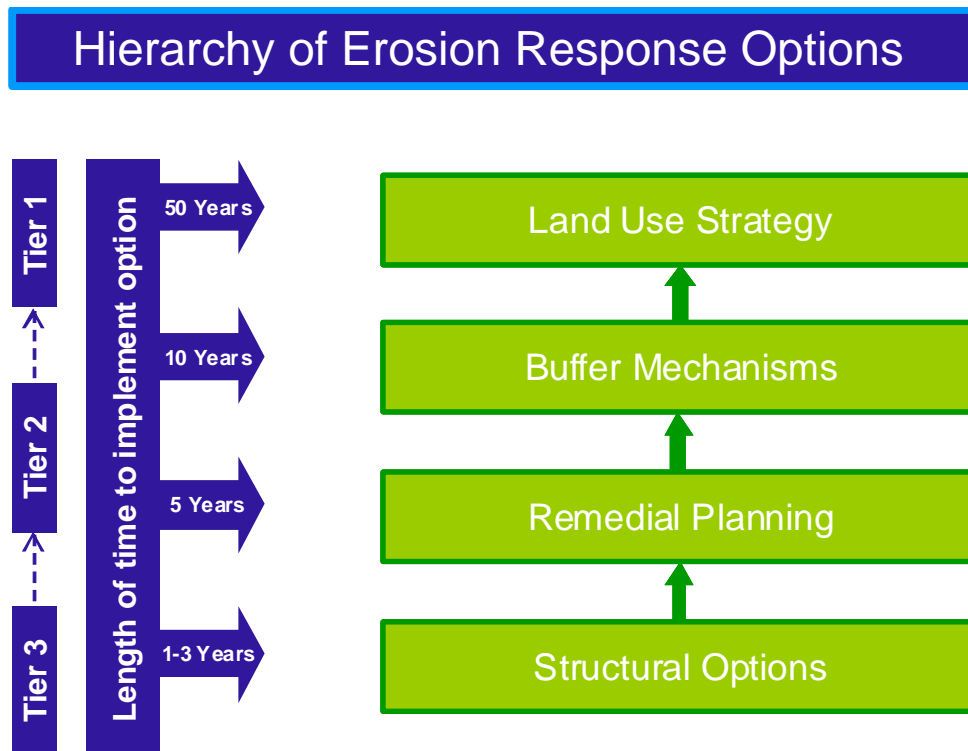
While the Tier 1 Options (most preferred) are more easily applied to undeveloped land, its implementation in areas where the shoreline has already been developed is more difficult. Although more rarely undertaken, remedial planning techniques such as planned retreat can be used where the strategic drivers outweigh the difficulties in implementation. Based upon the hierarchy of response in the NZCPS, the focus in developed areas is usually on protecting assets, in which case soft structural options are recommended to be undertaken where possible, as opposed to hard structural options. The hierarchy of erosion responses is illustrated in Figure 6 below:

Figure 6. Hierarchy of Erosion Responses

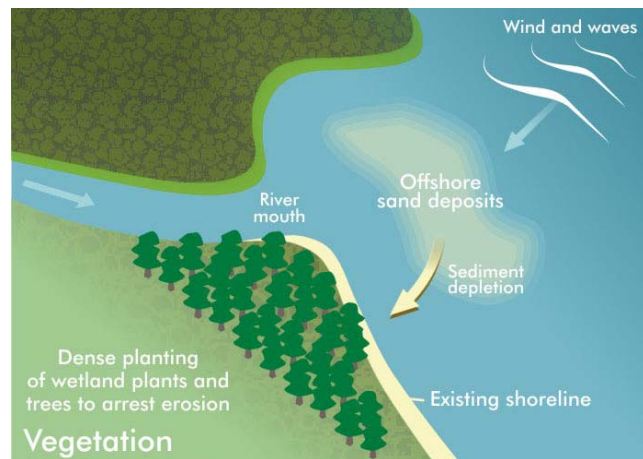
- Re-vegetation is applicable to all types of shoreline (both hard and soft sediment);
- Re-vegetation can result in habitat/ecosystems enhancement;
- Indigenous plant species can be used in re-vegetation;
- Has the potential to improve the quality of storm water and road runoff before it enters the lake.
- Re-vegetation can assist in improving amenity; and
- Re-vegetation schemes can be used as a good means of involving local communities in erosion protection schemes.

Figure 8. Re-vegetation

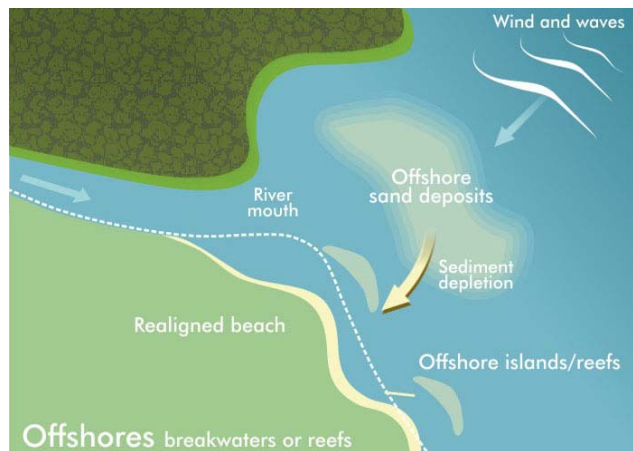
- Expensive to design and construct as they are offshore; and
- Is a potential navigation risk.

Figure 11. Offshore Breakwaters

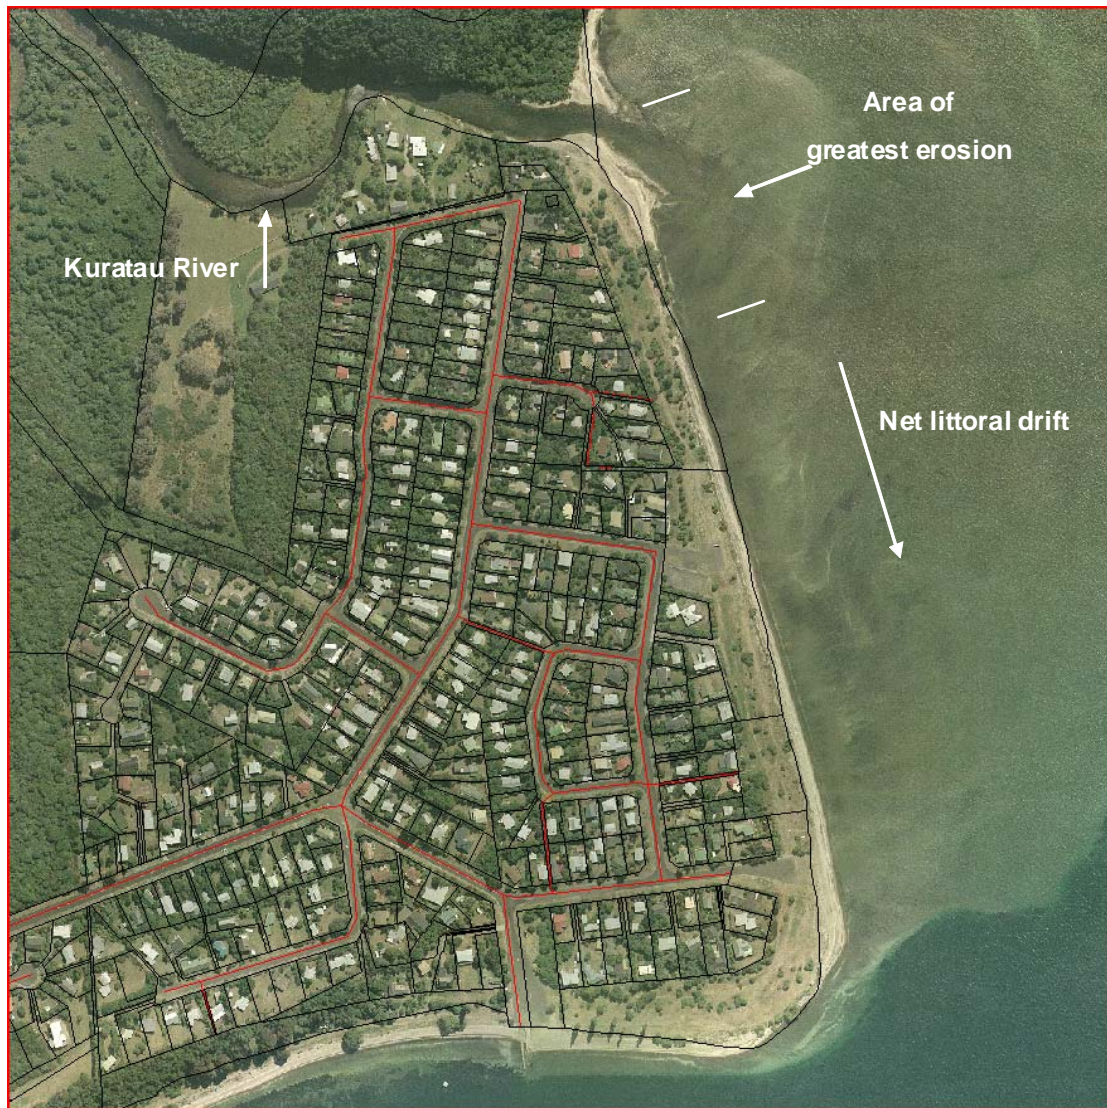
Photo 1. Kuratau [2003]

The development of Kuratau has occurred over the flat and gently sloping floodplain area. These low lying areas were formed from the natural deposition of sediment originating from the Kuratau River over time. The beach largely retains a natural sandy character with few erosion control or other structures. The full length of the shoreline has a reserve area between the foreshore and private land of approximately 20 - 40m in depth and is predominantly grassed with some trees and bushes.

During land development in the early 1900s significant clearance of bush was undertaken for forestry. This resulted in significant erosion within the upper catchment and increased sediment loads. This erosion has since largely been controlled through landuse controls and stabilisation.

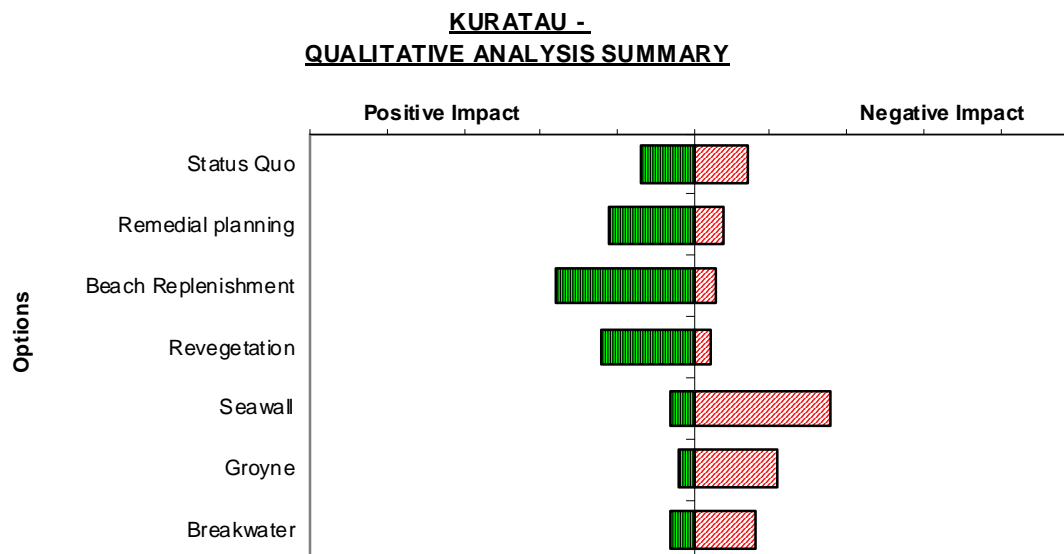
The graph below shows, in summary form, the results of the qualitative matrix for Kuratau. The results show that the soft structural options having the greatest positive impacts with the least negative impacts. The hard structural options have similar levels of positive impacts to each other, with the seawall having the greatest level of negative impact. The status quo and remedial planning options have medium level of positive impact relative to other options.

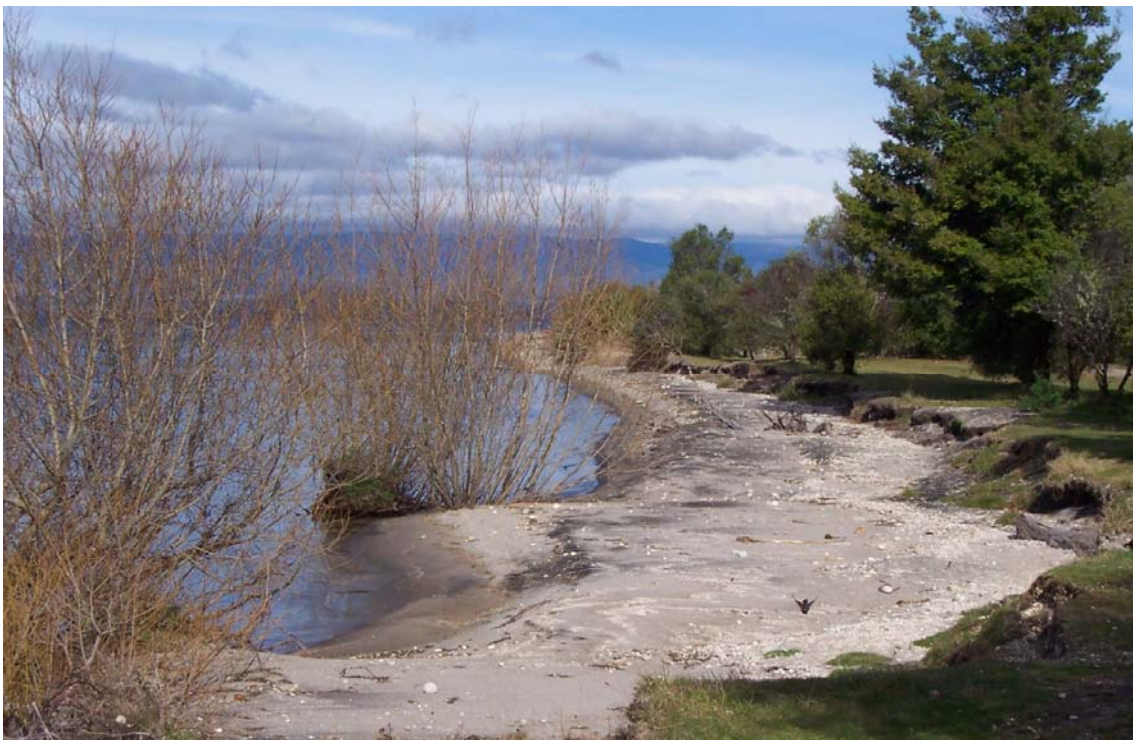
Photo 2. Kuratau scalloped beach, August 2005

A better understanding is needed of the complex processes in action at this site through monitoring and a sediment budget, before predicting the equilibrium position. This is a complex process and will require an assessment of the sediment budget for the area. This is best covered in a site specific study. This should take into consideration in more detail the sediment inputs into the system from the Kuratau River, the local wind and wave environment and sediment transport rates.

If further inaction is not considered acceptable the options of beach replenishment and re-vegetation may buy some time and allow for further analysis of the shoreline processes and justification for the implementation of a combined solution such as using beach replenishment with containment structures such as groynes or the use of an offshore breakwater. The money used for the initial beach replenishment may however be lost and further replenishment would be required along with the installation of any containment structures.

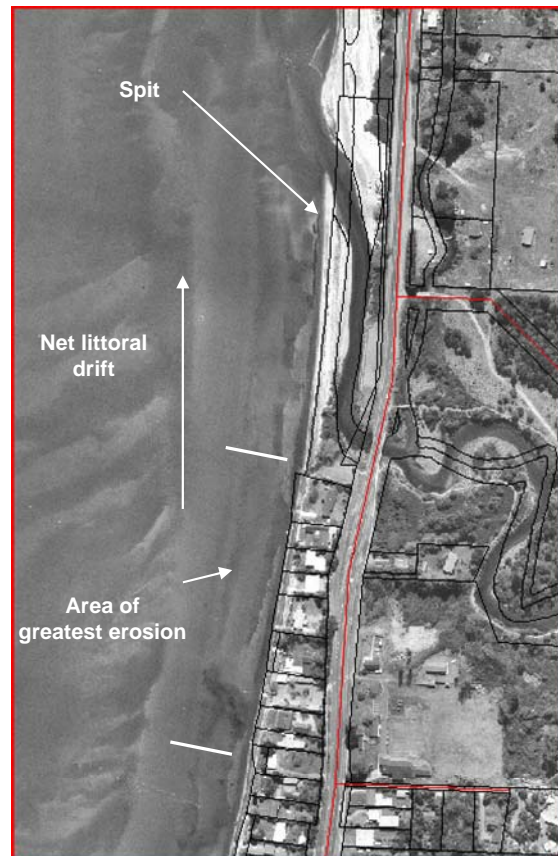
Photo 3. Waitahanui [1999]

The mouth of the Waitahanui, like most streams or rivers is a dynamic area, this can be seen by the cycles that the river mouth and spit go through where the discharge location can move up to several hundred metres north of the location where it breaks into the river. Areas in close proximity to the river mouth could therefore expect cyclical periods of erosion and accretion as the river and lake processes work in their own cycles.

Development within or close to the likely fluctuation zone has also meant there has been the construction of hard, shore parallel erosion protection measures of various forms along

this stretch of shoreline. Some of these structures are causing erosion problems at either end, adding secondary erosion issues.

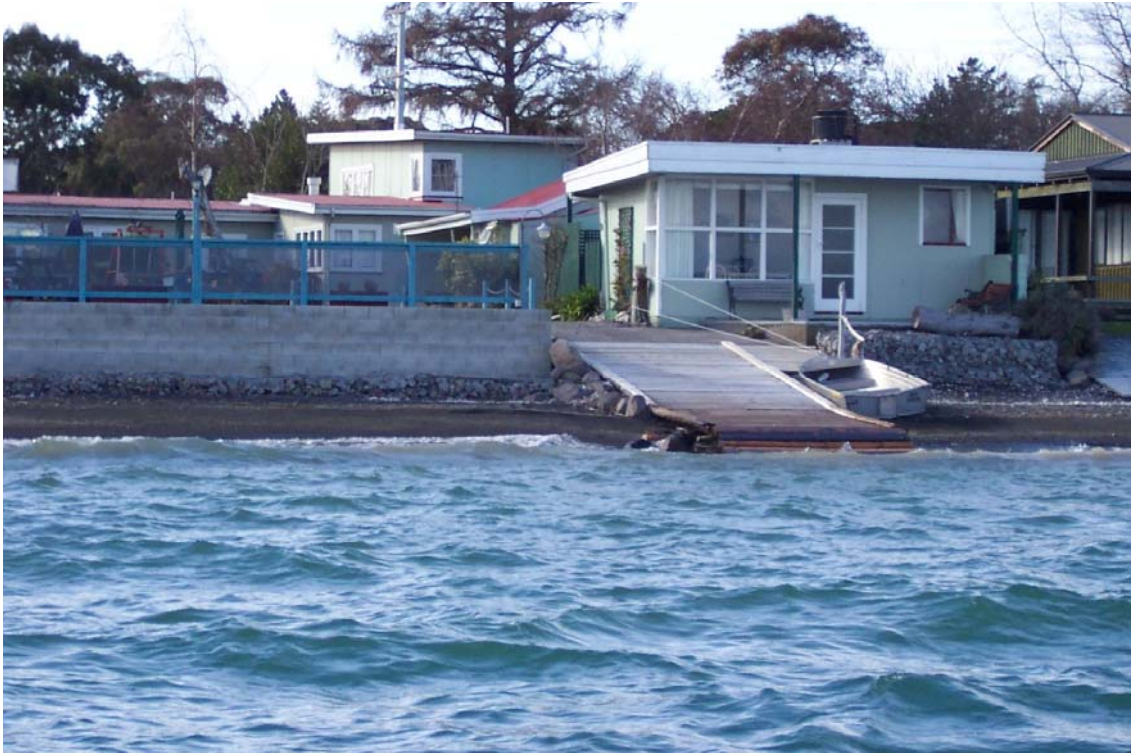
Photo 4. Waitahanui boat ramp, August 2005

As described above, the area to the south of Waitahanui stream mouth has a number of homes, many of which have extensive protection structures in place. The distances from the shoreline to the houses range from approximately 10m-30m. During severe storms these low level defences would not be suitable to withstand wave forces. It also appears from the type of protection put in by the landowners that some infilling behind them has taken place. Existing seawalls and boat ramps have been undermined in many areas along Waitahanui. Along the length of shoreline with the most significant erosion the public services (e.g. sewer) are located on the landward side of the houses. Further to the south there is approximately 420m of sewer between 20 – 40 m from the shoreline. Two main stormwater outfalls exist along the area of risk.

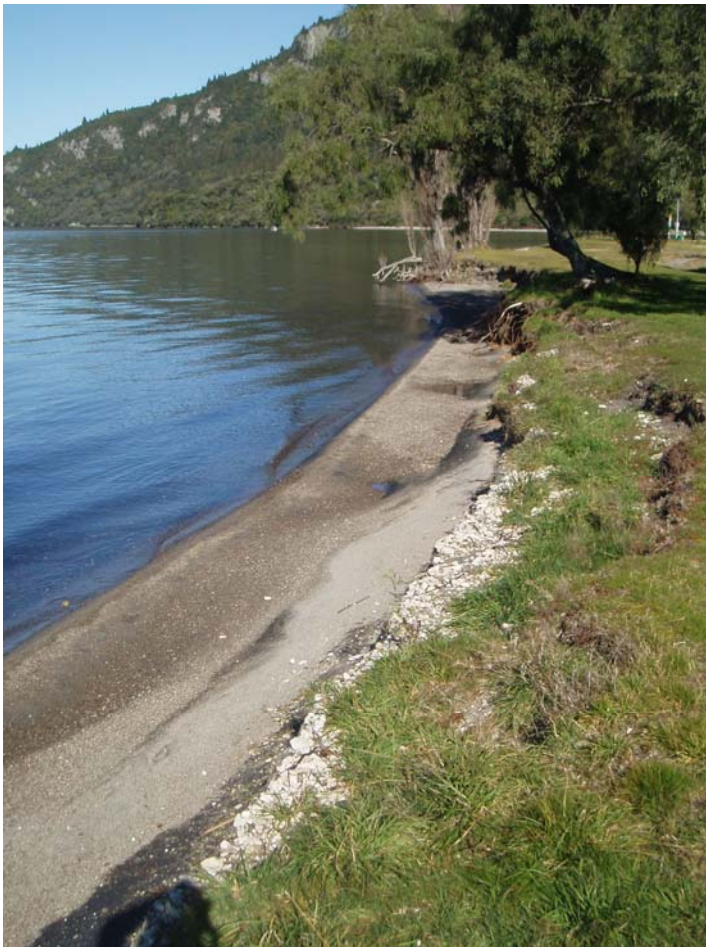
Photo 6. Whareroa shoreline, July 2006.

The key asset at risk from erosion hazard is the public reserve that runs along the foreshore. Some existing poplar trees which are considered to be of high visual amenity value to the local community are also at risk. Other services and water supply boreholes etc are currently located well back from the shoreline. The ramp itself has required responsive protection measures to prevent cutting at the side.

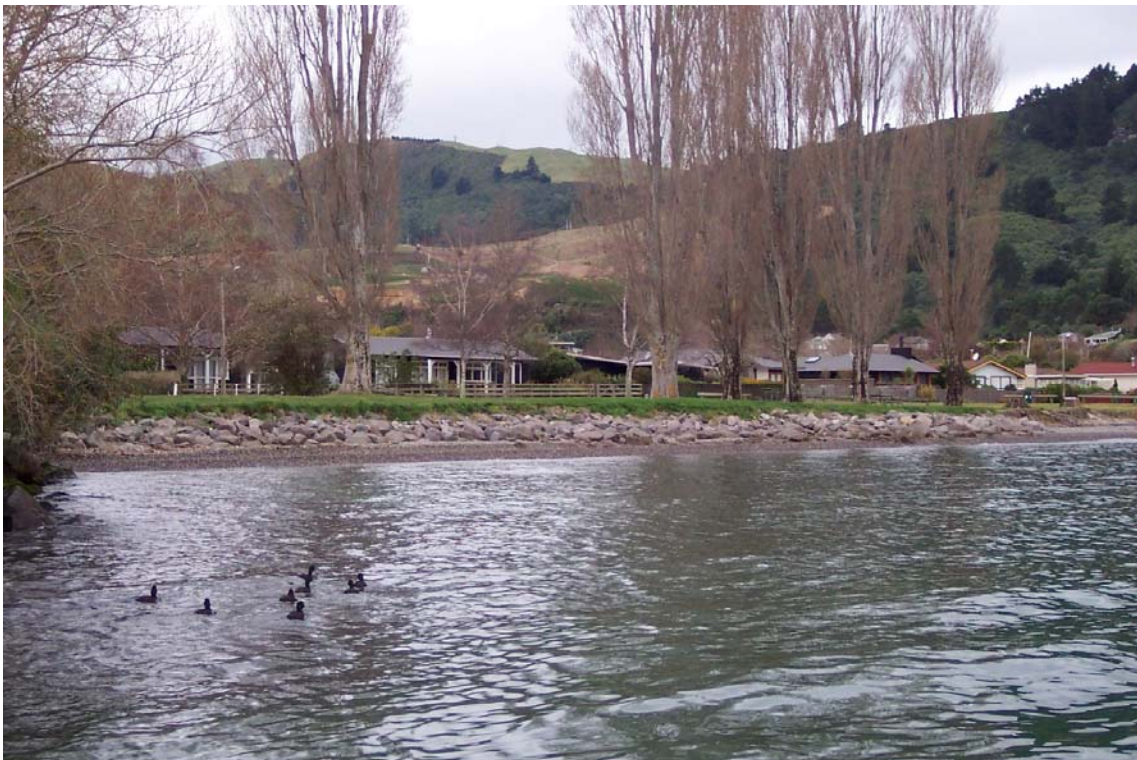
The situation at Kinloch is one of a post implementation phase of the installation of a rock seawall in response to erosion events in 2004. As part of the expansion of the marina there were also plans to carryout beach nourishment in front of the revetment creating a buried seawall. This process was held up due to getting approvals for the nourishment. The result is that the wall has assisted in stabilising the erosion area, however the character of the beach and access has been affected. Secondary or localised erosion/scour has also occurred at the end of this rockwall structure (i.e. ‘end effects’).

Photo 8. Kinloch rock wall, August 2005

1. Monitor performance of the wall and in particular any end effects and internal soil erosion.
2. Continue to investigate options for undertaking beach replenishment in front of the wall if its aesthetic impacts are not acceptable.

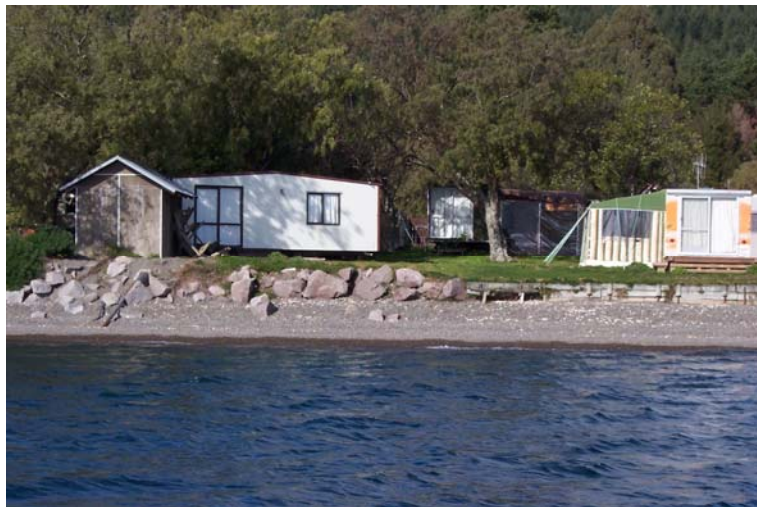
Rock walls built in front of private properties to protect against erosion are located along the Point, and there are a number of small informal wooden structures providing protection to the campsite area. There is one main boat ramp servicing the campsite, along with a number of smaller ramps along the houses.

Photo 9. Motutere rock wall and wooden structure mix, August 2005

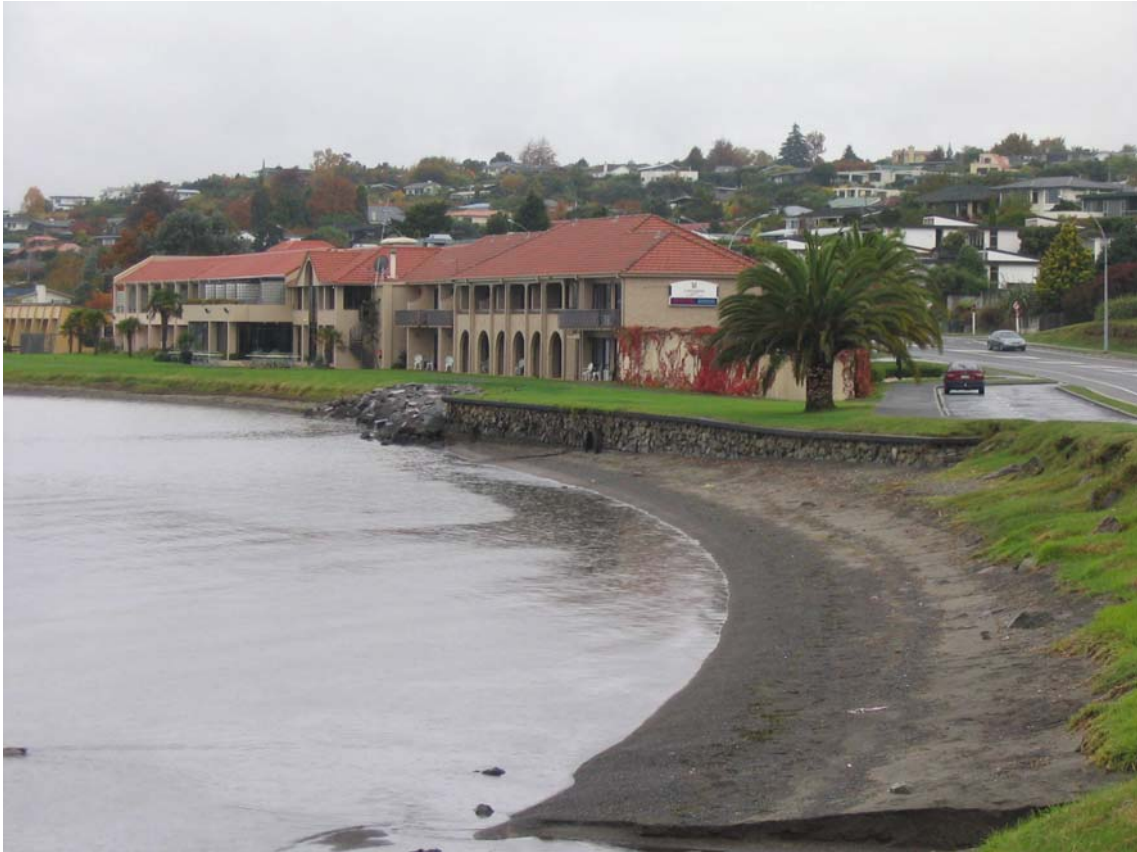
In addition to the various assets and infrastructure listed above, there is also risk to a number of the erosion control structures themselves. Many of the structures have not been designed appropriately and suffer from erosion at the ends or at the toe (Kirk 2000).

Photo 11. Taupo Township mix of structures, May 2005

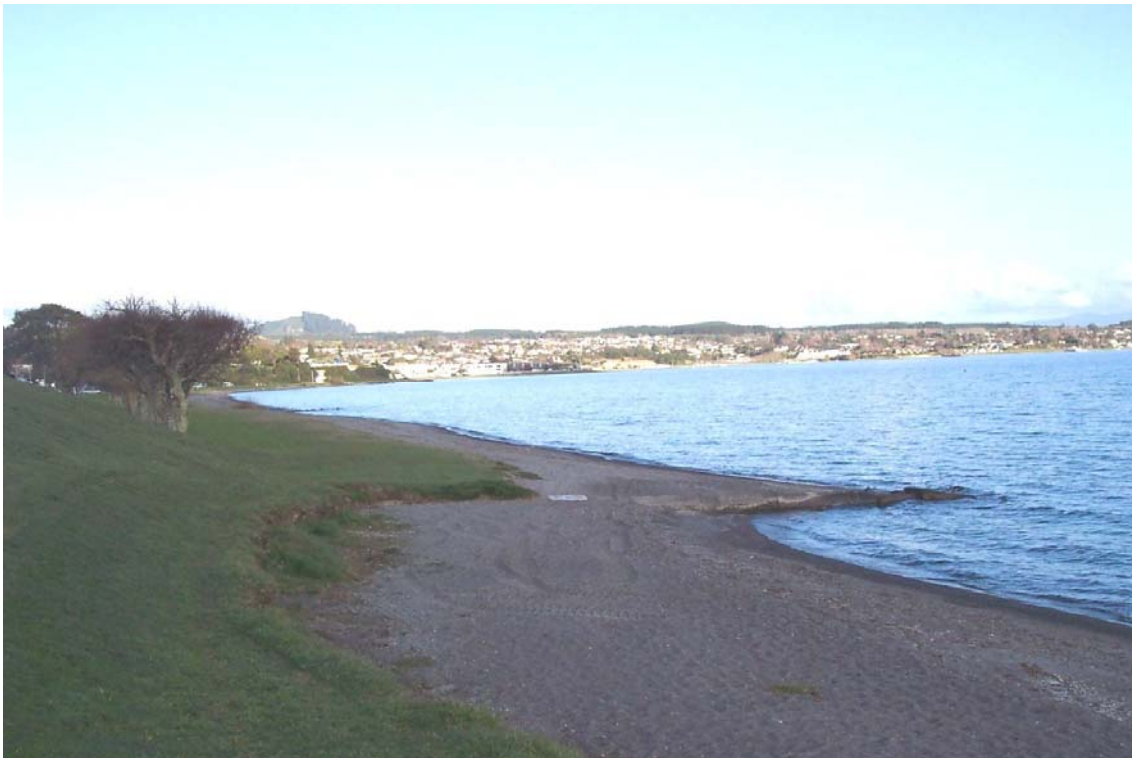
Photo 12. Taupo Township beach, August 2005

- The development of a consistent approach to any hard protection where it is necessary is recommended.
- Asset surveys of existing structures to understand their performance, and expected life.

- Monitoring of beach profiles to better understand the lake processes in this area.
- Modelling of the wave climate and refraction/diffraction/shoaling processes so as to better describe the equilibrium state of the bay.

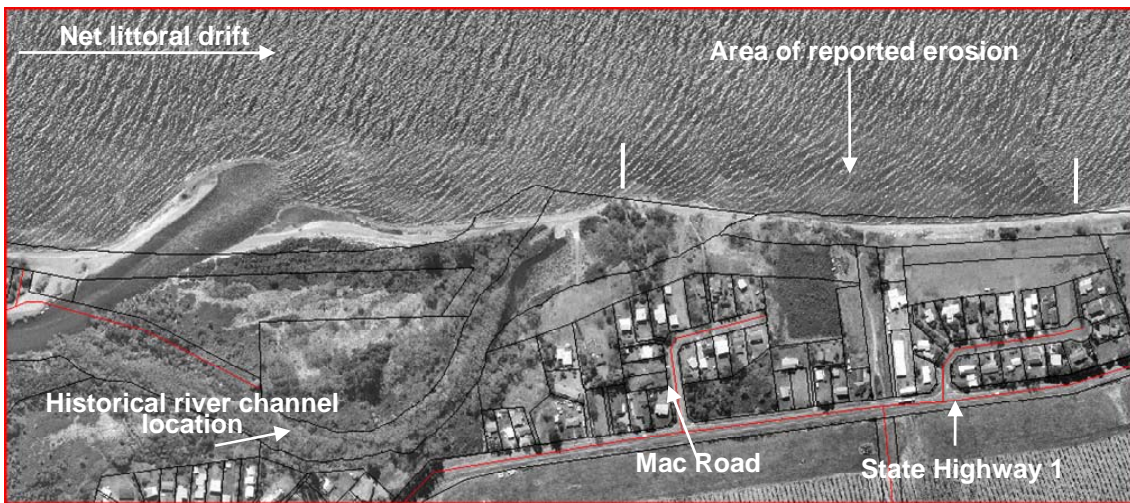
Photo 14. Te Rangitta, [1999]

The primary area of erosion at Te Rangitta is the length of shoreline immediately to the east of the Tauranga Taupo River mouth, extending beyond Mac Rd to the Te Rangitta Reserve. This area has historically shown fluctuations (1946, 1958, 1993 aerial photographs NIWA 2001) and is considered to be predominantly based on the variations related to the proximity to the river mouth. Since the river mouth was artificially relocated in 1958 the cusped feature has continued to erode. Ongoing gravel management takes place upstream in the Tauranga Taupo by SH1, this may be removing material that would have otherwise made it to the shoreline.

The land use along the area of erosion is predominantly reserve (Te Rangitta Reserve), an unconstructed road reserve, and the former silted up mouth of the river. There are limited assets at immediate risk in this area, however some reserve area is being lost and a council toilet exists.

1. Instigate beach profile monitoring,
2. Consider soft options such as re-vegetation along grass reserve areas.

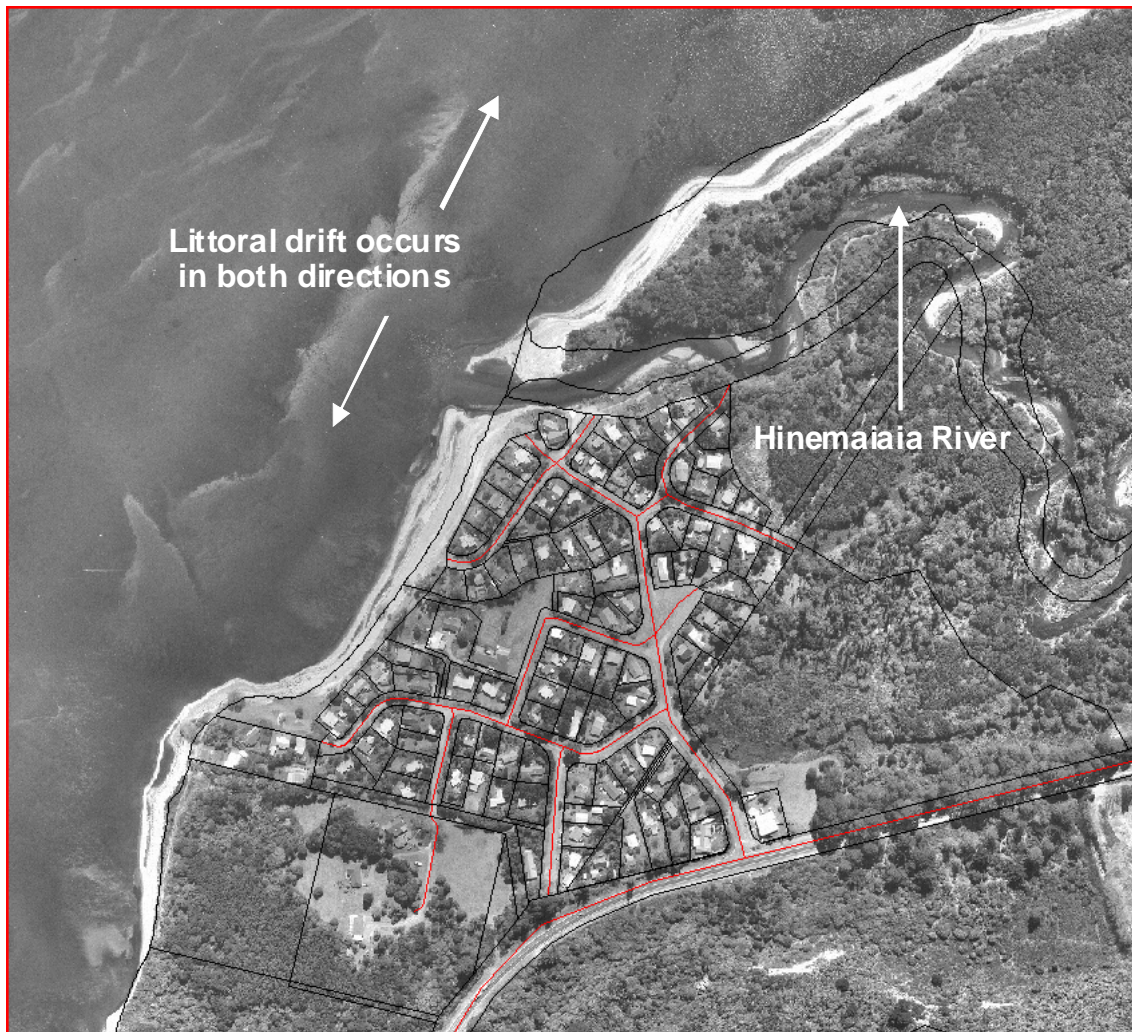
Photo 16. Hatepe, [1999]

Near Hatepe at the Hinemaiaia river mouth, the shoreline appears to be stable with no scarps along the foreshore. A stormwater pipe headwall has been in the same location for 20-30 years. Even though over that period of time sediment outputs have been reduced by the hydroscheme, there is no evidence at present of erosion in this area. Sediment available in the nearshore may be assisting offsetting losses from the river. It is understood that the river mouth can change direction depending on the prevailing wind and stream conditions, however there is a net northerly littoral drift for the compartment. Some erosion has been reported to the south of the river mouth, but it is largely attributed to the natural variability of the river.

Previous shoreline monitoring has not been undertaken in Hatepe, and this is recommended prior to any implementation of erosion options. Any river training works to manage the location of the mouth of the river should also consider the potential for any impacts on sediment supplies to the beach system.

1. Undertake shoreline monitoring prior to actioning any particular options.
2. If erosion is found to be unacceptable carryout a site specific study to determine the most appropriate response.
